# CLEARROOT MATERIALS

## EXAMPLE INVESTIGATIONS

### Representative Materials Failure Analysis & Characterization Examples

Demonstrating ClearRoot Materials' systematic approach to failure analysis, materials characterization, contamination investigations, and root-cause determination.

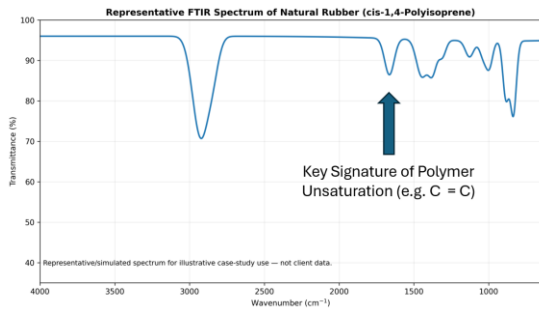
Functional Group	Natural Rubber (cm <sup>-1</sup> )	EPDM (cm <sup>-1</sup> )	Structural Indication
C-H Stretching	2960, 2850	2920, 2850	Present in both
C=C Stretching	1660-1664	None	Primary fingerprint for unsaturation
C-H Methyl Bend	1445, 1374	1460, 1380	Present in both
C=C-H Wag	830-840	None	Sign of <i>cis</i> -1-4, NR

**Figure 3. Representative cartoon FTIR spectrum of natural rubber (cis-1,4-polyisoprene). Spectral analysis identified the failed material as an unsaturated elastomer susceptible to ozone-induced degradation under long-term environmental exposure. Image generated for illustrative purposes to demonstrate analytical identification of elastomer materials.**

Fine surface cracks were observed perpendicular to the applied strain direction (**Figure 2**). The crack morphology is consistent with classical ozone attack. FTIR spectroscopy identified the failed material as natural rubber (cis-1,4-polyisoprene), an unsaturated elastomer known to exhibit poor resistance to long-term ozone exposure (**Figure 3**).

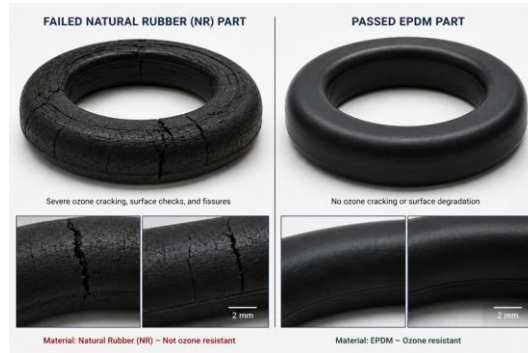
**Figure 5: Comparison of Failed Natural Rubber Part with EPDM Part.**

- 1) Replaced existing natural rubber with ozone-resistant EPDM
- 2) Updated material specifications with ozone exposure requirements
- 3) Added accelerated ozone testing to qualification protocols
- 4) Implemented supplier material verification requirements (**Figure 5**)

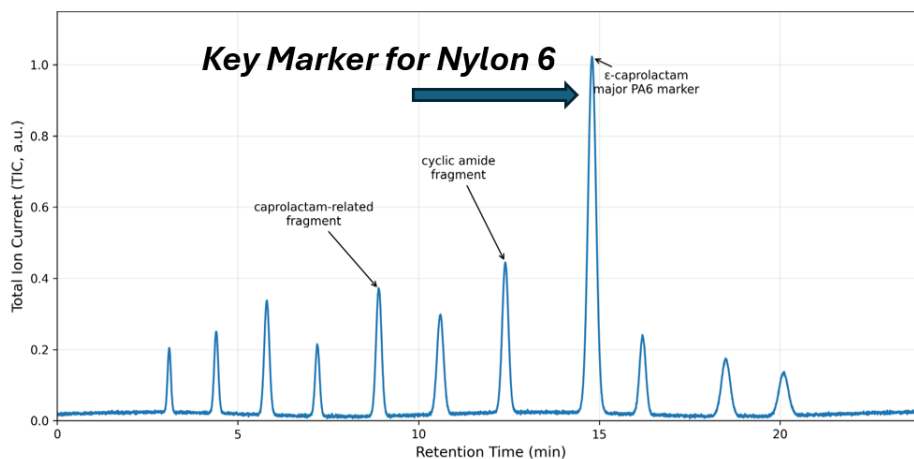
### Representative Py-GC/MS Pyrogram of Nylon 6 (PA6)

**Figure 2: Example pyrogram illustrating characteristic Nylon 6 (PA6) decomposition products. Image generated for illustrative purposes to demonstrate the type of analytical data used during material identification investigations.**

FTIR analysis identified the material as a polyamide (PA). Py-GC/MS subsequently confirmed the material to be Nylon 6 and NOT Nylon 11 or Nylon 12 through identification of characteristic  $\epsilon$ -caprolactam pyrolysis product (**Figure 2**). While Py-GC/MS confirmed all candidate materials contained a Nylon 6 chemistry, additional characterization was required to determine whether the formulations, including fillers, were truly equivalent.

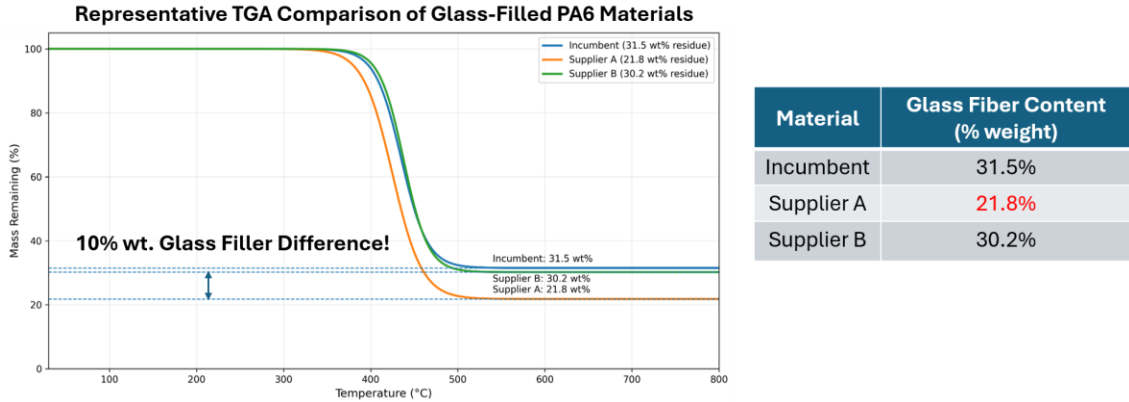
**Figure 3: Example thermogravimetric analysis revealed that Supplier A contained substantially less inorganic reinforcement than the incumbent material despite both being marketed as 30% glass-filled Nylon 6. The results demonstrate the value of analytical characterization during supplier qualification and material substitution programs. Thermal image generated for illustrative purposes for educational reasons.**

SEM/EDS and TGA characterization revealed 31.5% glass fiber reinforcement in the incumbent material compared to 30.2% (Supplier B) and 21.8% (Supplier A) (**Figures 3-4**). Comparative analysis demonstrated that one of the proposed replacement materials was not compositionally equivalent despite similar supplier descriptions.
